5.16 Wy Yung Recreation Reserve

The following details the condition of the existing floodlighting installation and observations from our site inspection at the Wy Yung Recreation Reserve, located at 60 Bullumwaal Rd, Wy Yung.

5.16.1 General Condition of Floodlighting Installation

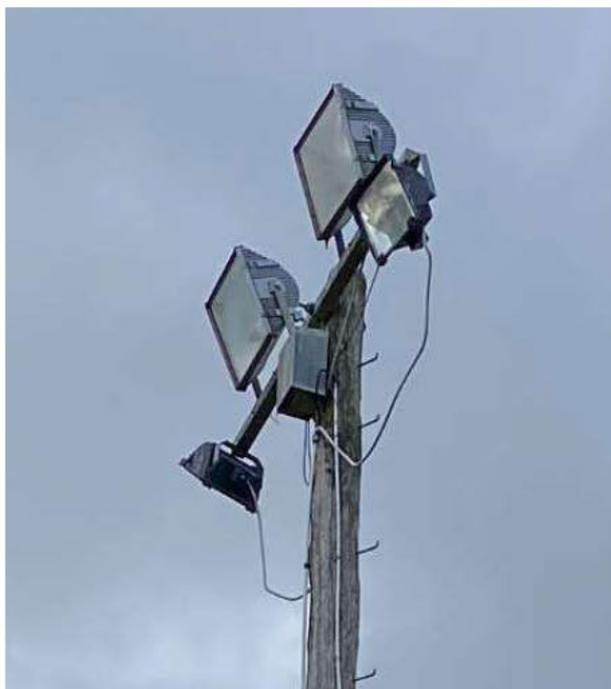
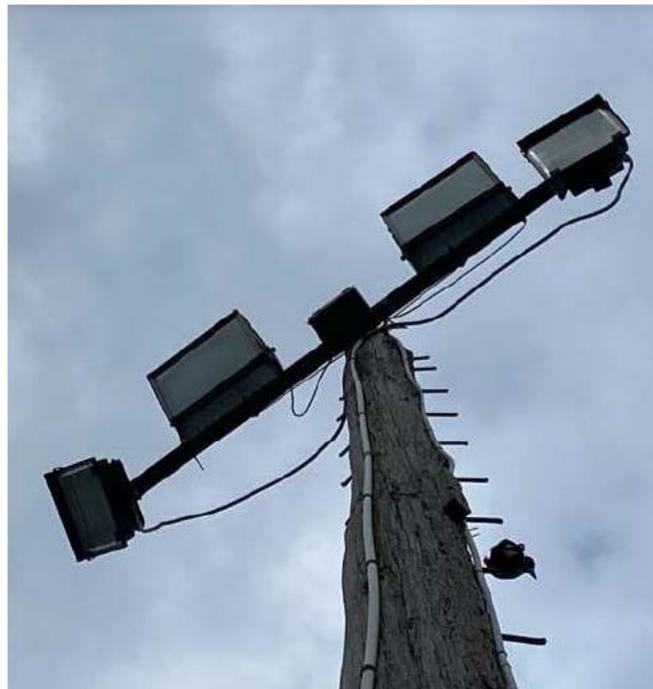
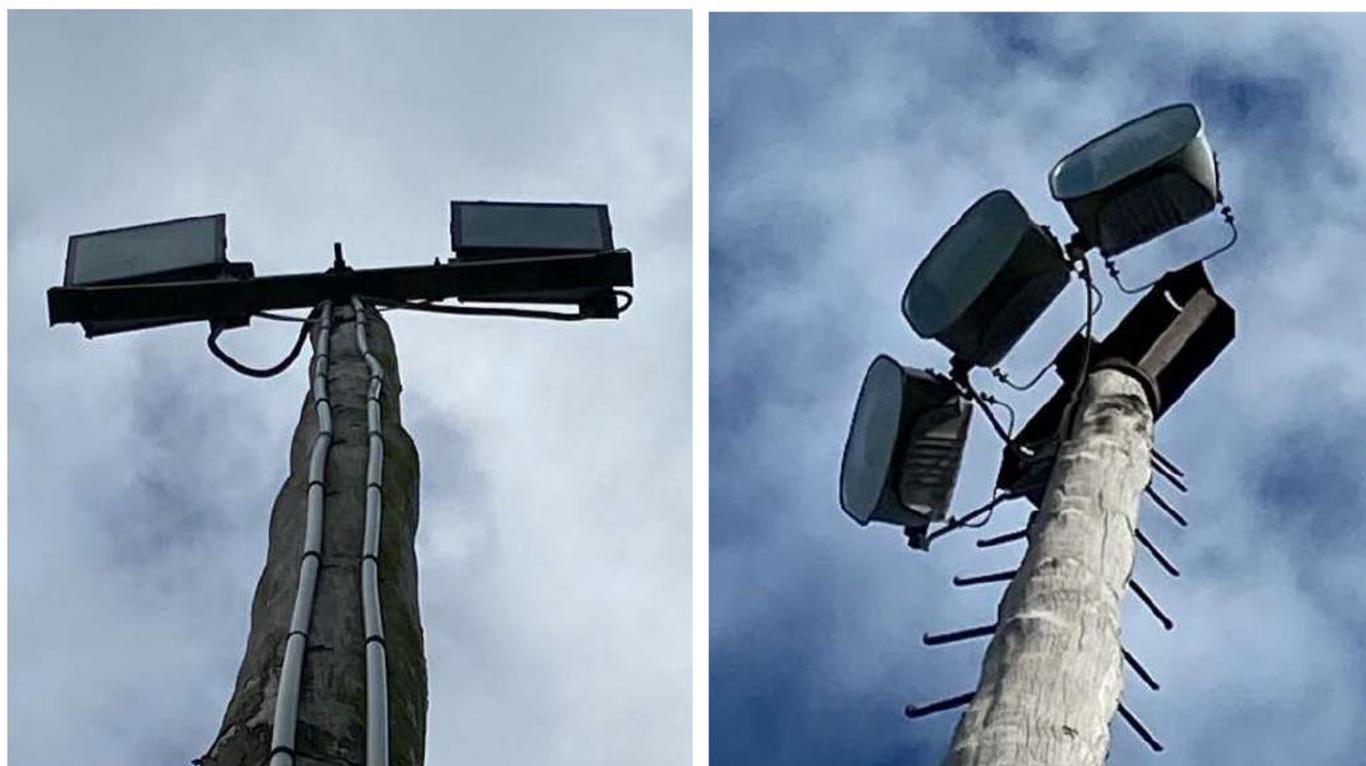
From our observation at ground level, the existing floodlighting installation appears to be of a poor standard. There are 4 no. existing fixed timber poles surrounding the oval, each approximately 10m tall containing a varying quantity of floodlights. The pole to the north-east of the oval contains 2 no. approximately 2000W metal halide floodlights, the pole to the north-west of the oval contains 2 no. approximately 2000W metal halide floodlights, the pole to the south-east of the oval contains 2 no. approximately 2000W and 2 no. approximately 1000W metal halide floodlights, and the pole to the south-west of the oval contains 3 no. approximately 2000W metal halide floodlights.

The existing floodlights appear to be aimed at an angle which may present a high level of glare to players and surrounding roads which would likely not meet the recommendations of the Australian Standards AS2560.2-2021 and AS4282-2019 respectively. In addition, the existing pole heights do not comply with the recommended pole heights in AS2560 for an oval of this size.

Football Oval – Existing Floodlights

- + **Suitability to Re-use Existing Pole Infrastructure:** The re-use of existing floodlighting poles to retrofit new LED floodlights is not feasible due to the poor condition of existing timber poles and lack of existing available structural information on existing pole and pole footing design. In addition, the poles are not high enough for an AS2560.2 compliant floodlighting design.

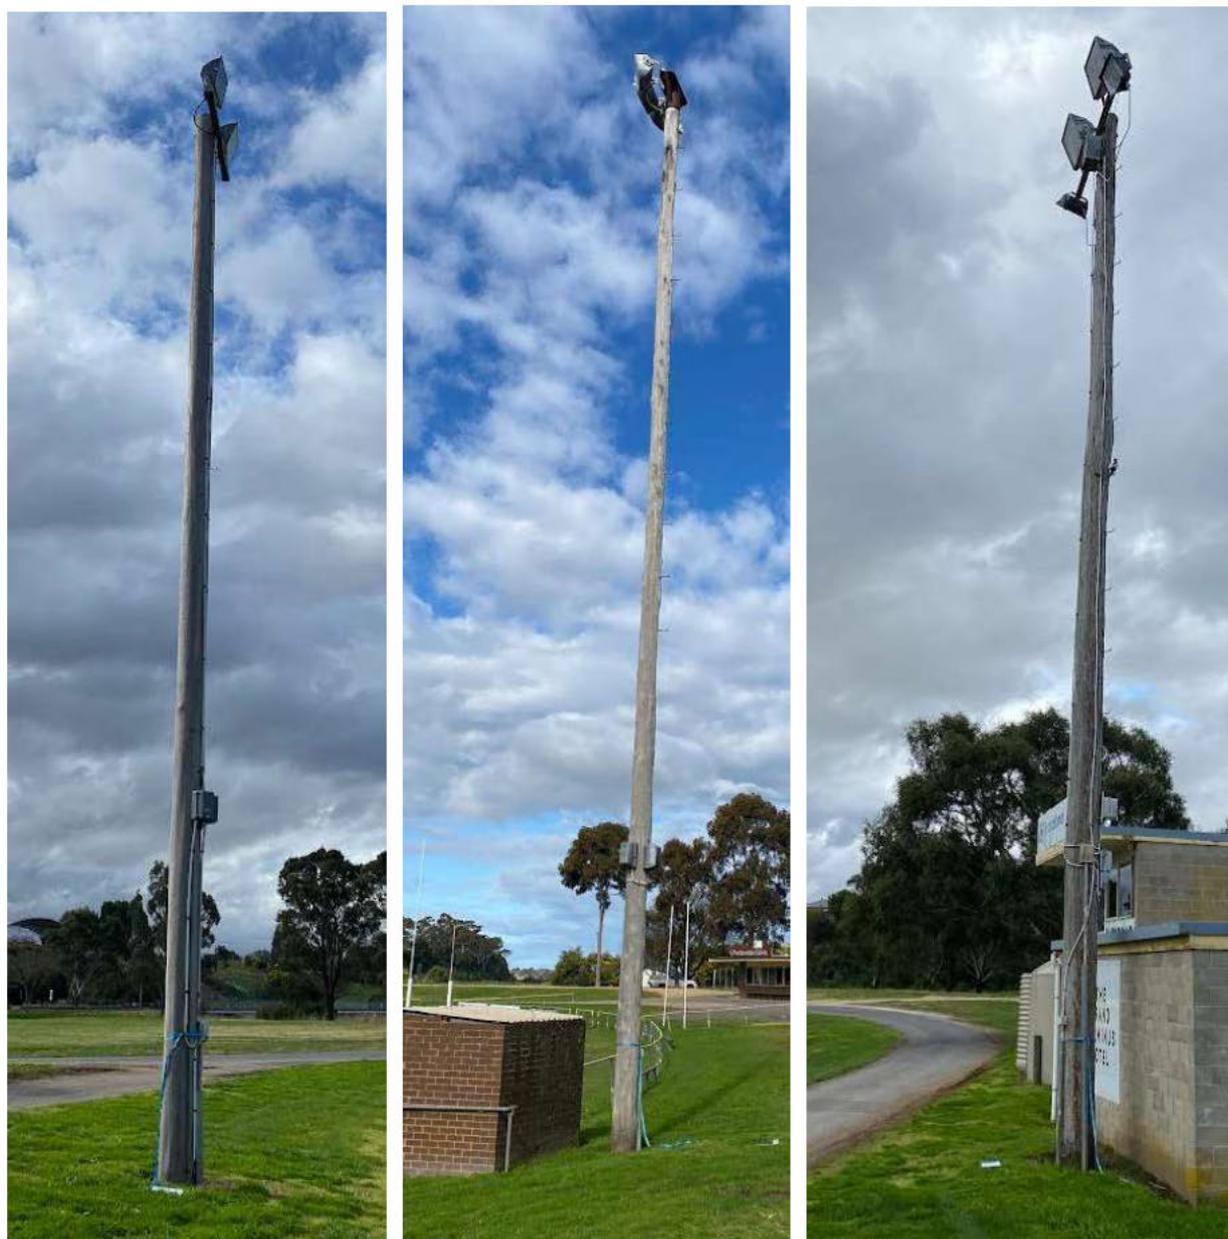
The pole footings were not visible for the existing poles. We assume that the existing footings would be in poor condition based on the condition of the existing poles and age of the floodlighting installation.

Football Oval – Existing Floodlighting Poles

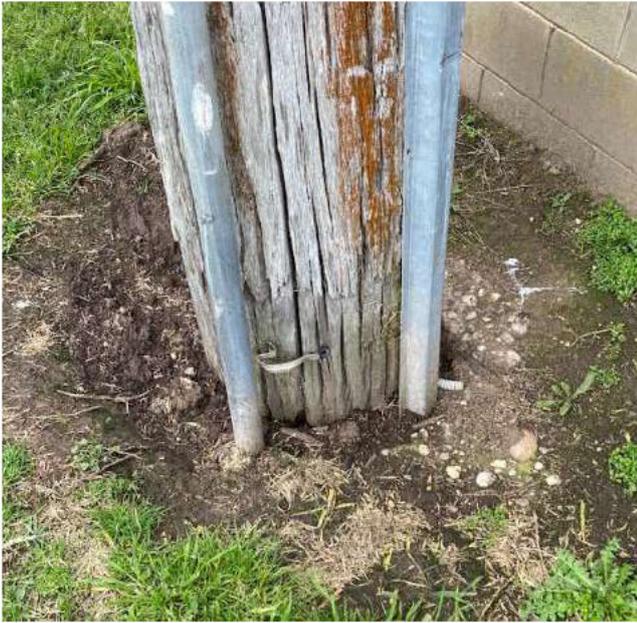
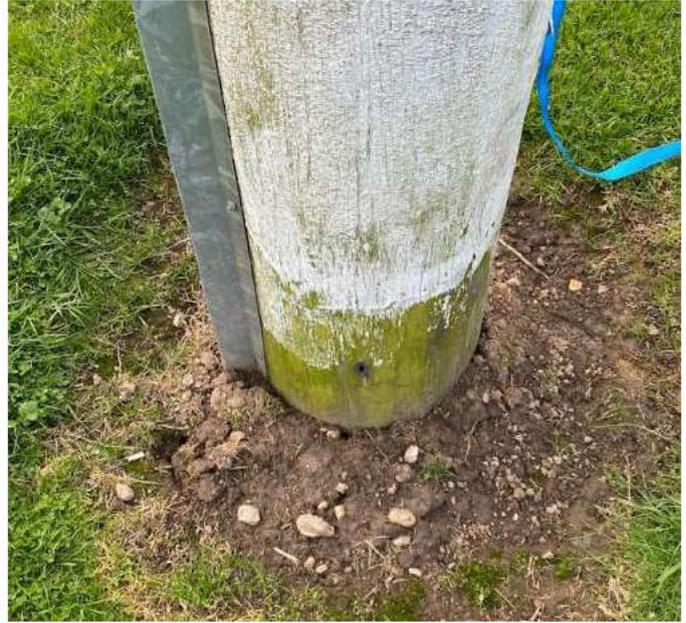
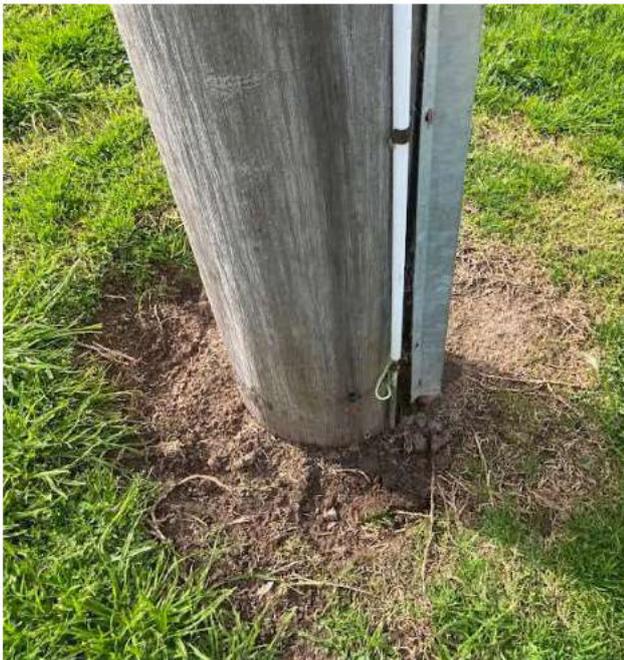
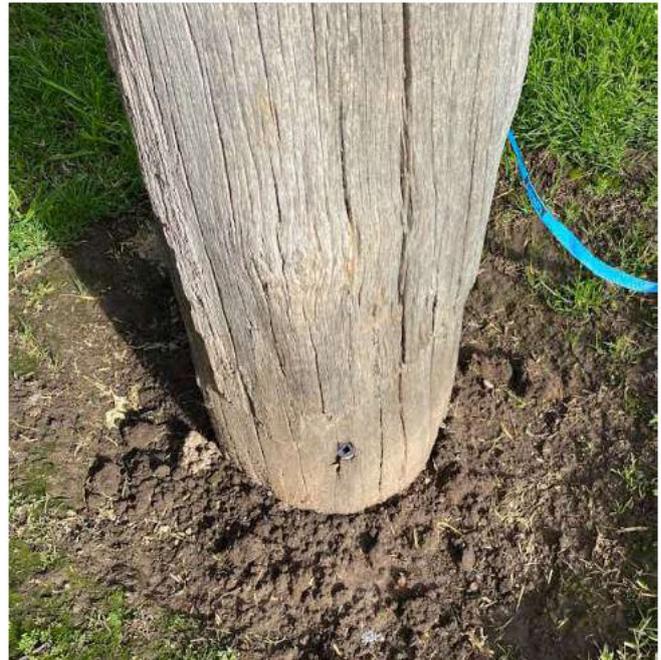
Football Oval – Existing Floodlighting Pole Footings
